## Original article

# Assessment of Tuber Damage in Potato Harvesting as Affected by Variety, Harvesting Speed, and Physical Characteristics

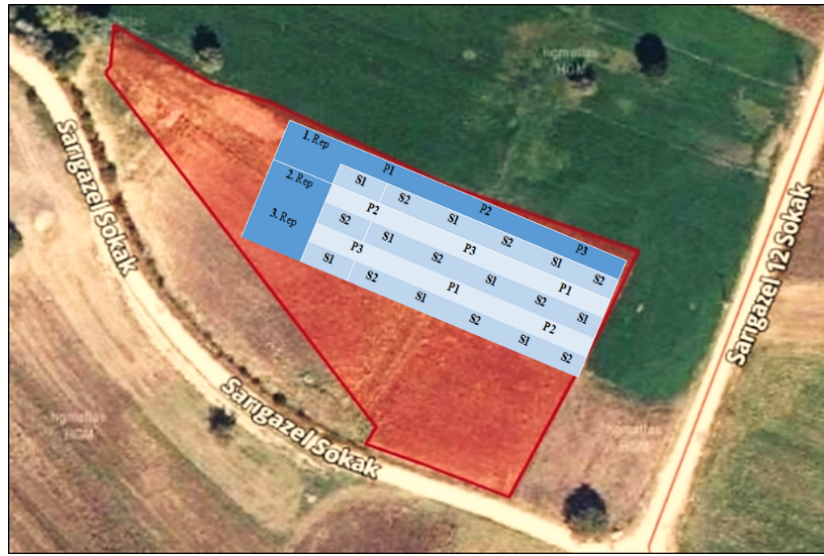
The field experiments were conducted on parcel number 639, block 0, located in the Günüveren area of Sarıgazel Neighborhood, Ladik District, Samsun Province (Figure 1).

**Figure 1.** The experimental field and layout

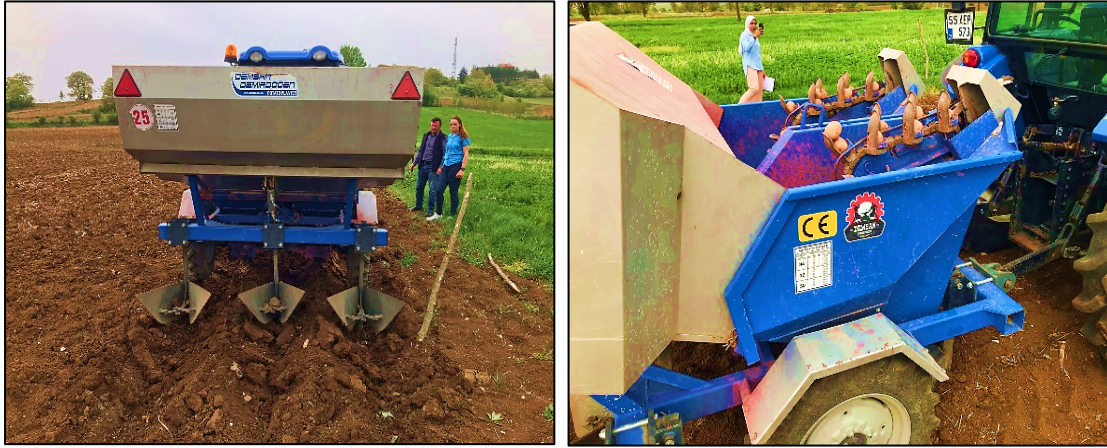
A two-row potato planter of the brand Demsan (Figure 2) was used in the experiments, and some of its technical specifications are presented in Table 1.

**Figure 2.** The planter used in the experiment

Specifications	Values
Total empty weight	593 kg
Equipment type	Semi-mounted planter
Drive type	Wheel-driven
Number of rows	2
Row spacing	700-750 mm
In-row planting distance	230,250,270,290,300,310,330,350,360,390,410 mm
Working width	1400 mm
Working depth	150-200 mm
Number of seed carrier cups	2x32
Number of cupped chain conveyors	2
Seed size	Diameter: 30-100 mm
<b>Overall dimensions</b>	
Width (W)	1.750 mm
Length (L)	1.900 mm
Height (H)	1.495 mm

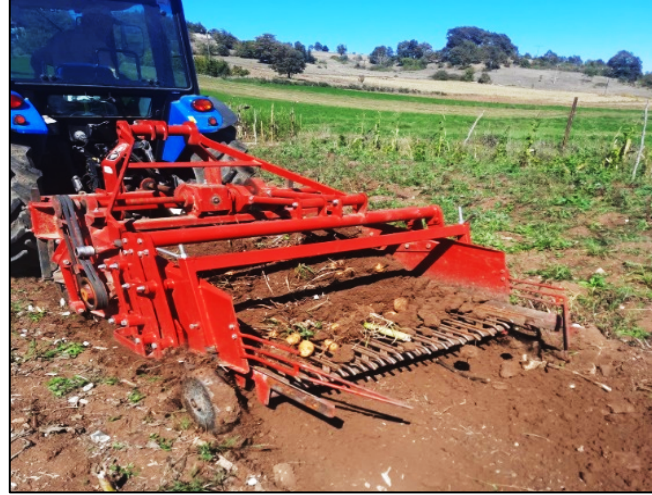
A two-row potato harvester of the brand Demsan (Figure 3) was used in the experiments, and some of its technical specifications are presented in Table 2.

**Figure 3.** The harvester used in the experiment

Specifications	Values
Type of attachment	Semi-mounted
Drive type	PTO-driven
Number of working rows	2
Row spacing	700-750 mm
Working width	1.400 mm
Working depth	200-250 mm
Number of blades	9
<b>Overall dimensions</b>	
Width	1.750 mm
Length	2.500 mm
Height	1.200 mm
Weight	714 kg

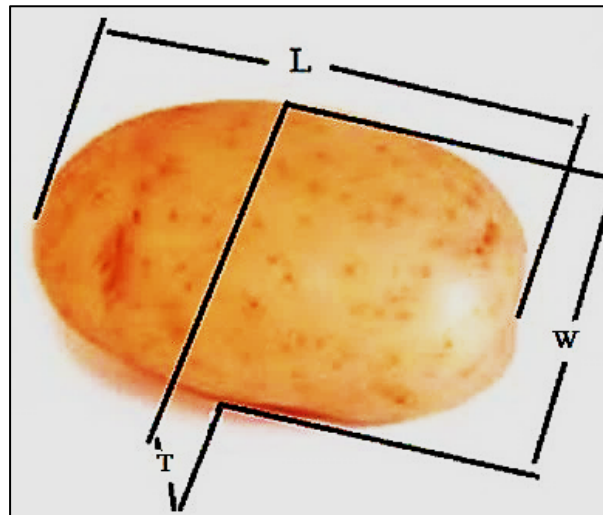
After harvesting, the width, length, and thickness of each selected tuber were measured using a caliper (Figure 4) to determine mechanical damage (Almady et al, 2024). Tubers were collected from the designated plots during harvest in the experimental field. The surface area of the tubers was calculated using Equation 3.4, and the deformation areas were determined by calculating the ratio of the deformed surface area to the total tuber surface area. Based on the data obtained from these measurements, the mechanical damage conditions were evaluated according to the varieties and harvesting speeds using the GMD, TV, TSA, and SP values (Mohsenin, 1986; Kara, 2017).

**Figure 4.** Measurements taken from the potato tuber: length (L), width (W), and thickness (T)

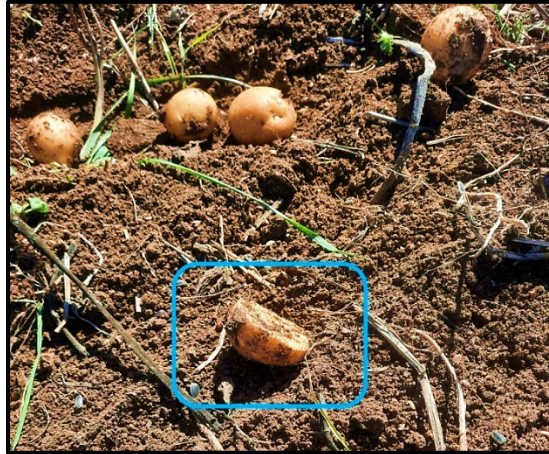
In addition to mechanical damage caused by the harvester during potato harvesting, deformities such as tuber cutting or fragmentation were also identified (Figure 5) and evaluated in these cases.

**Figure 5.** Example of a tuber fractured during harvesting

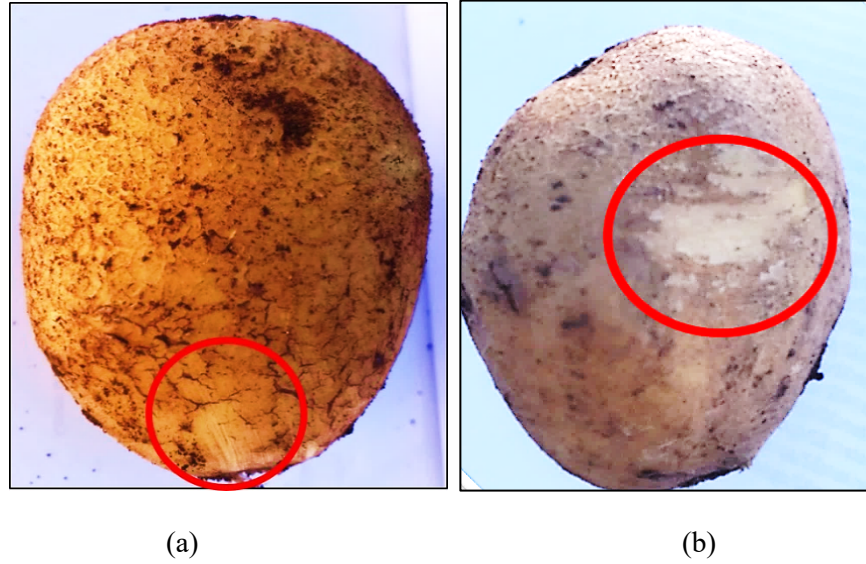
**Figure 6.** Potato tubers exposed to mechanical damage

During harvest, the MD rate was recorded as 6.16% for the P1 (a) and P2 varieties, and 4.86% for the P3 (b) variety (Figure 6). It can be inferred that the P1 and P2 varieties used in the experiment were more susceptible to damage during harvesting with the semi-automatic potato harvester compared to the P3 variety.
